MEMORANDUM OF PETITION

To: The Chief Executive Officer / Chief Engineer (P&D),
Polavaram Project Authority (PPA),
Rajahmundry, Andhra Pradesh – 533143

From: Centre for Liberty (Represented by A.B. Venkateswara Rao, and Nalamotu Chakravarthy)

Subject: Petition demanding an immediate halt to ECRF Dam construction pending independent scientific verification of Gap-II D-Wall integrity, rectification of Gap-I deviations, resolution of Approach Channel dredging, and fixing of contractor accountability for the collapsed guide bund.

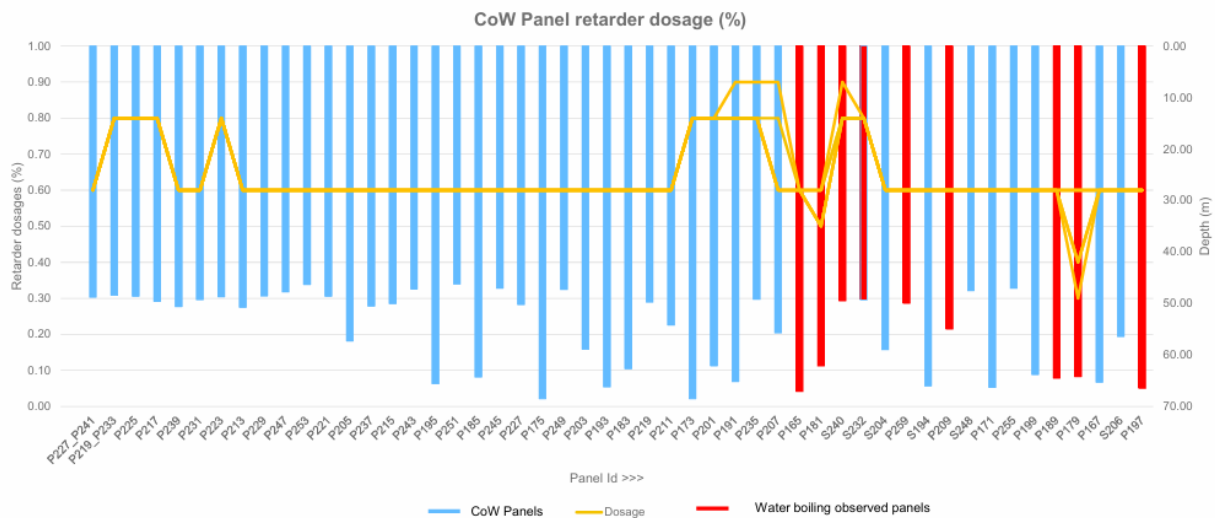
3.1 Retarder dosage in CoW Panels % - Bleeding !

- **Source Document:** *Bauer-Bleeding-Presentation-2025.05.05-Project Presentation.pdf*
- **Description:** This slide from the contractor's own technical presentation features a graph explicitly tracking the numerous panels where the "water boiling" effect was observed. It includes a technical note admitting to a "deviation of methodology" and acknowledges that concrete was supplied at delayed intervals "for the purpose to reduce the water boiling effect," yet "water boiling/drainage was still observed". This serves as the contractor's documented admission of the mechanical failure.

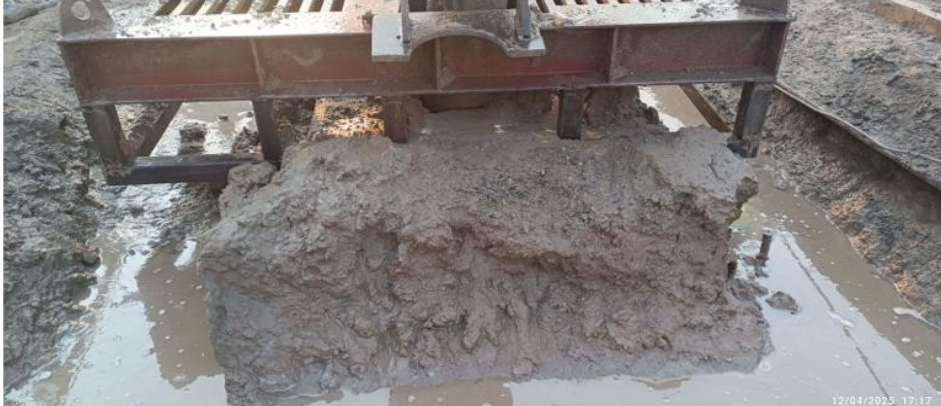
3.4 Deviation of methodology in CoW concrete supply

- A decision taken to delay concrete supply and pouring for the upper 10 meters of the panel by supplying concrete trucks at 30-to-60-minute intervals for the purpose to reduce the water boiling effect. However, this has caused difficulties in overflowing the contaminated concrete, and water boiling/drainage was still observed.
- Target reduced the bleeding → Reducing setting time → No advisable to delay concrete delivery as seen above.
- P181 is shown as an example in the photograph above.

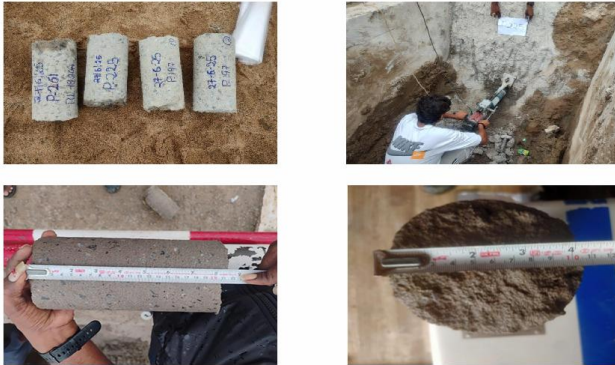
PHOTOGRAPHS TAKEN DURING CORING::

- **Statistically Insignificant Surface Testing:** The project cleared 50-to-100-meter deep bleeding panels based entirely on horizontal core samples extracted from merely the top 1.5 meters of the wall of the five panels. Testing the top 1.5% of a wall provides zero scientific proof that the deep foundation is safe from vertical bleed channels.

- **Source Document:** *PoE-visit ^N5-PPT on Compliance to RFI 11 Dt.28.08.2025-1.pdf*
- **Description:** A set of photographs showing extracted horizontal core samples (clearly labeled with panel numbers P-261, P-225, P-197) and a worker operating a horizontal coring machine directly into the shallow face of the exposed wall. This visually proves that the integrity of 50-to-100-meter deep panels was certified using merely 8-to-9-inch horizontal surface samples, completely bypassing deep vertical testing.

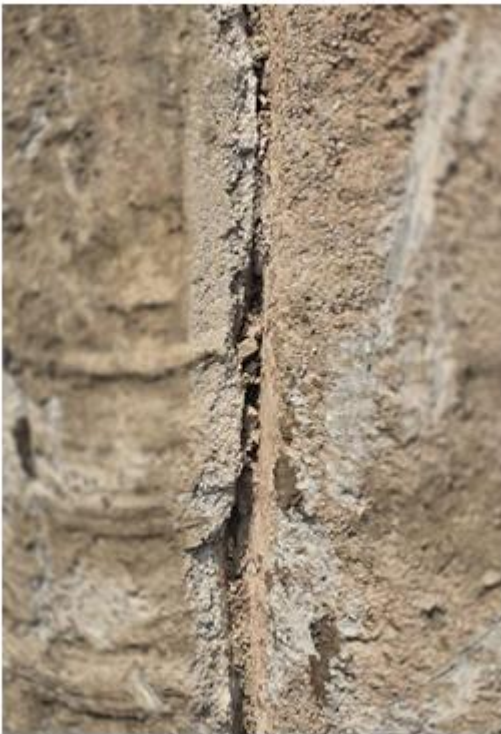
Annexure 3: Visible Panel Cracks & Overlapping Failures

- **Photographic Evidence from PoE Visit 6:** During Site Visit No. 6 in January 2026, the Panel of Experts documented the exposed D-Wall with critical photographs highlighting structural flaws and unauthorized practices. These photographs explicitly reveal visible vertical cracks and unacceptably wide gaps at the joints. The images also expose unauthorized physical cover-ups ("parging"), showing where the contractor slapped gray mortar over surface defects without providing a repair methodology or securing PPA acceptance.

- **Source Document:** *Panel of Experts (PoE) Visit 6 Report* (Figure 4-3)
- **Description:** A close-up photograph taken by the independent experts showing a severe, continuous vertical crack and a wide gap at the joint between two D-Wall concrete panels. This visually demonstrates the failure in panel overlapping, which
- provides a direct pathway for water seepage.

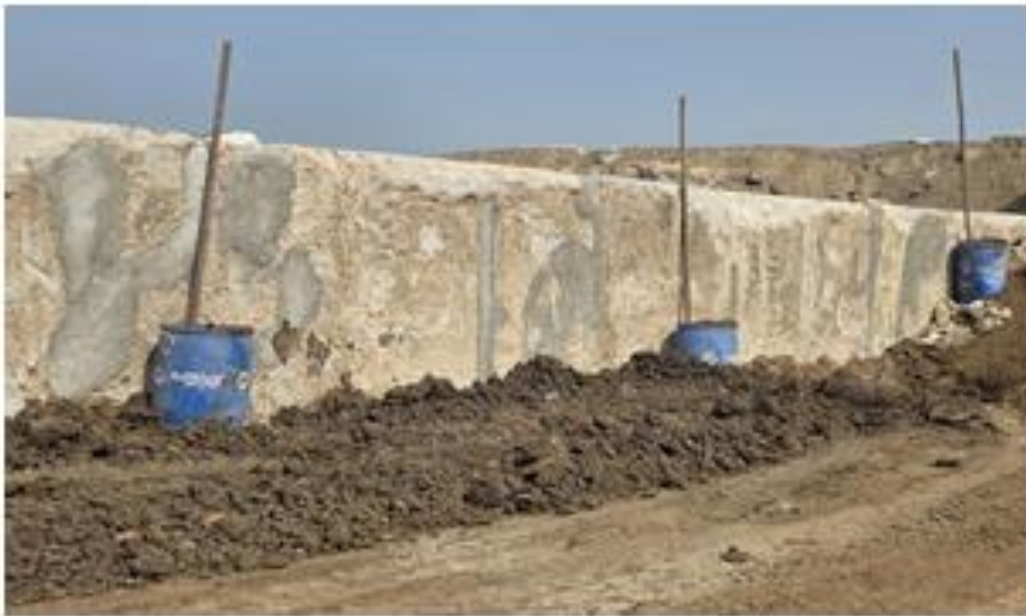
Annexure 4: Unauthorized "Parging" (The Physical Cover-Up)

- **Source Document:** *Panel of Experts (PoE) Visit 6 Report* (Figure 4-3, wider shot)
- **Description:** A wider photograph of the exposed D-Wall (identifiable by the blue "AdBlue" barrels in front of it) showing multiple areas where gray mortar and cement have been slapped over the wall's surface. The PoE explicitly flagged this "parging" as an unauthorized attempt to hide surface defects without an approved repair methodology.

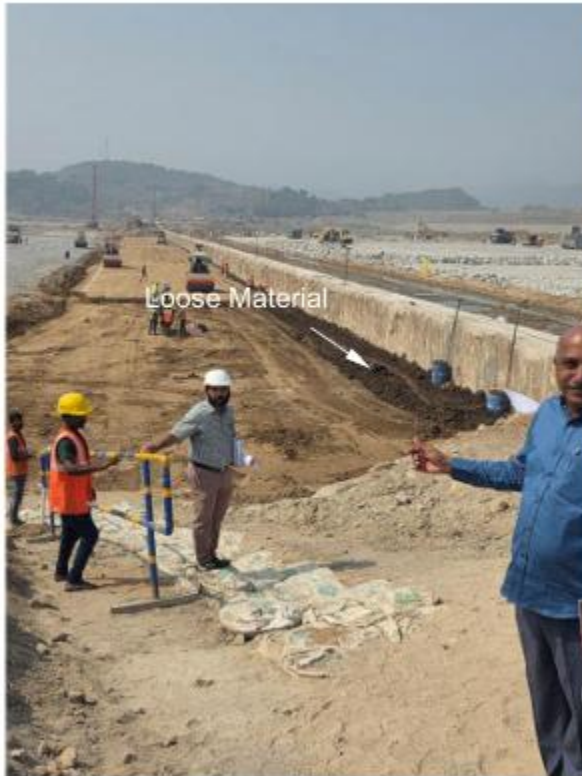
Annexure 5: Loose, Uncompacted Fill Against the D-Wall

- **Source Document:** *Panel of Experts (PoE) Visit 6 Report* (Photo 6-15)
- **Description:** A photograph of the impervious zone adjacent to the D-Wall featuring a white arrow added by the experts pointing to a 30 to 50 cm trench of "Loose Material". This highlights the contractor's failure to properly compact the critical clay contact zone directly against the concrete cut-off wall.

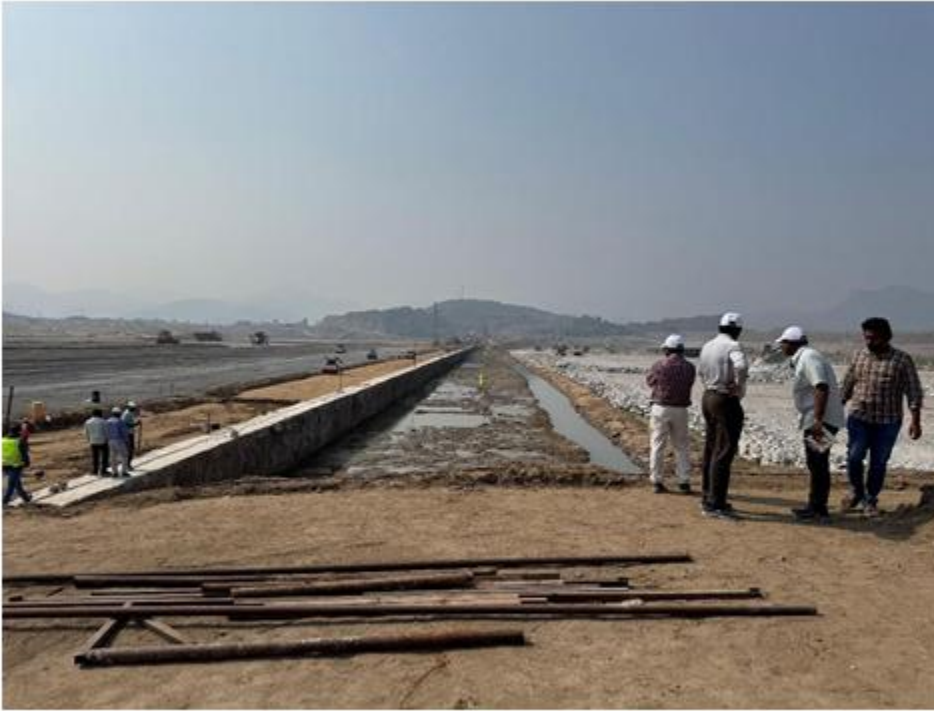
Photo 6-16: Concrete cutoff wall – GAP II Dam Cut at El. 18.5 m.

- **Source Document:** *Panel of Experts (PoE) Visit 6 Report* (Photo 6-16)
- **Description:** A photograph showing a long stretch of the concrete cutoff wall in the Gap-II Dam that has been physically chopped down to Elevation +18.5 meters. This serves as proof of the structural deviation from the original +19.0m design, necessitated by the need to remove defective, bleeding plastic concrete at the top of the wall.
